**Tioga County Property Development Corporation
Special Board of Directors
Wednesday, October 30, 2024, at 4:00 PM
Ronald E. Dougherty County Office Building
56 Main Street, Owego, NY 13827
Economic Development Conference Room #109**

O'Rourke Incorporated was contacted by Brittany Woodburn, Executive Director for the Tioga County Land Bank (Owner), to perform an initial Mold Assessment at the Residential Building located at 121 Providence Street in Waverly, NY. These services were performed in response to extensive water damage which occurred at this building. This service was performed by Mr. Steve Tiffany, a NYS-DOL Licensed Mold Assessor, on October 15 & 21, 2024. This letter and attachments constitute our report.

MOLD ASSESSMENT PHOTOGRAPHS

Residential Building @ 121 Providence Street - Waverly, NY

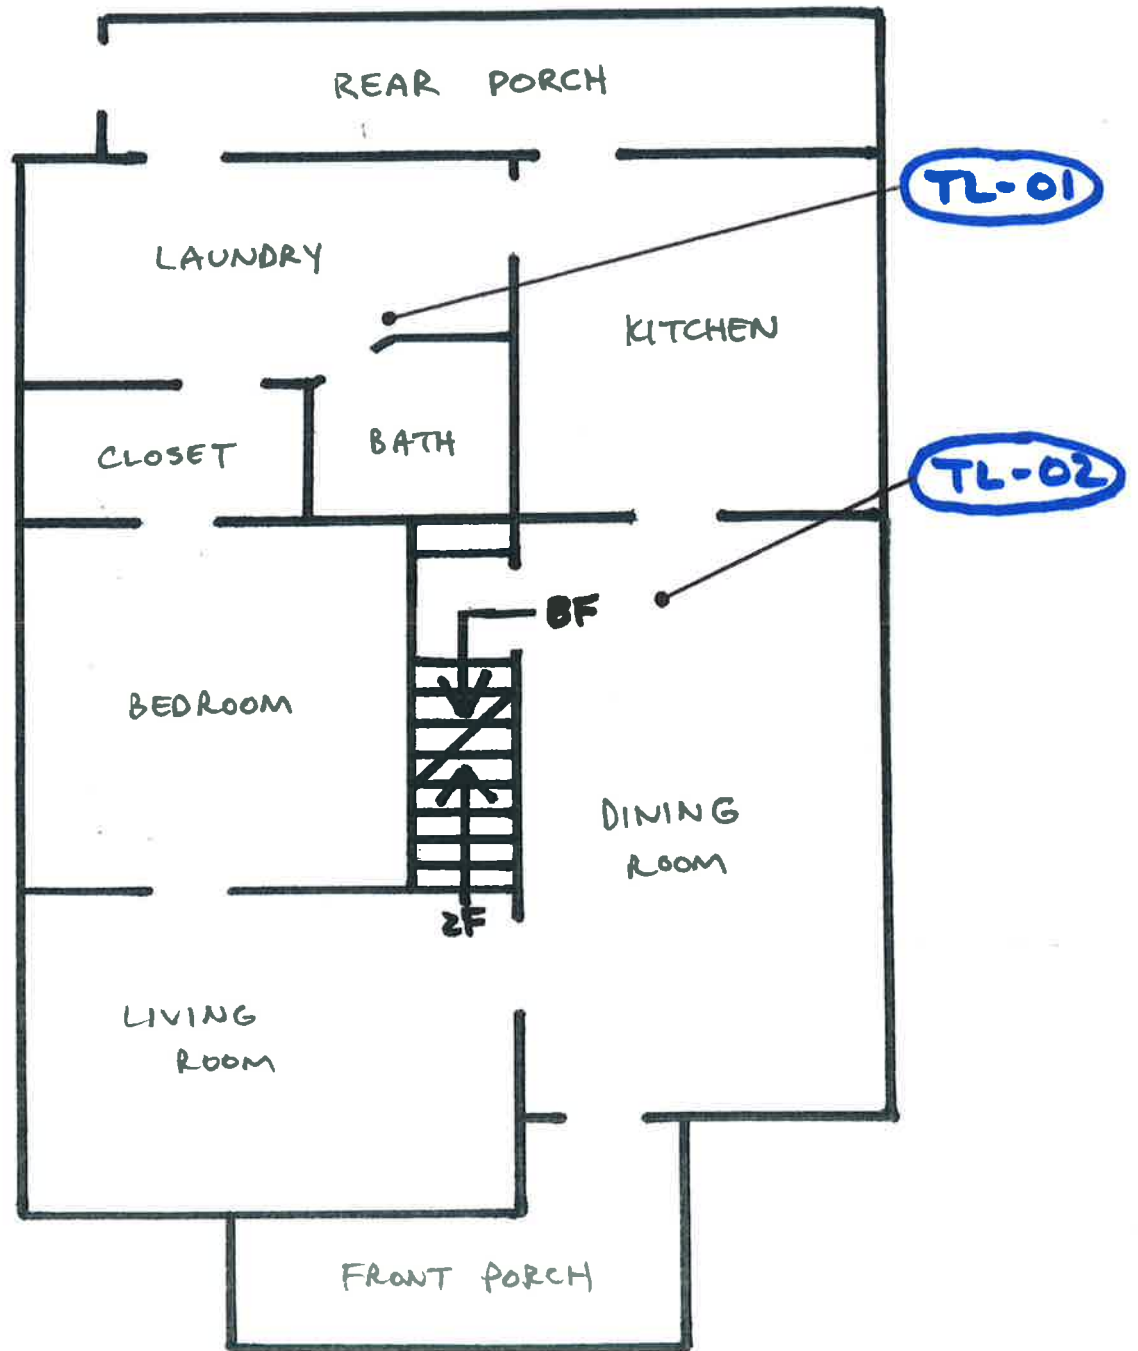
SAMPLE LOCATION DRAWING

Lab Sample Number:	532402188-0001	532402188-0002		
Client Sample ID:	TL-01	TL-02		
Sample Location:	1F - Back Room	1F - Dining Room		
Spore Types	Category	Category		
Alternaria (Ulocladium)	-	-		
Ascospores	-	Rare		
Aspergillus/Penicillium++	-	-		
Basidiospores	-	Rare		
Bipolaris++	-	-		
Chaetomium++	-	-		
Cladosporium	Rare	Rare		
Curvularia	-	-		
Epicoccum	-	-		
Fusarium++	-	-		
Ganoderma	-	-		
Myxomycetes++	-	-		
Pithomyces++	-	-		
Rust	-	-		
Scopulariopsis/Microascus	-	-		
Stachybotrys/Memnoniella	*High*	-		
Unidentifiable Spores	-	-		
Zygomycetes	-	-		
Acremonium++	*High*	-		
Aspergillus	*Low*	*High*		
Bispora	-	Rare		
Monodictys	-	Rare		
Hyphal Fragment	-	Rare		
Insect Fragment	-	Low		
Pollen	-	-		
Fibrous Particulate	Rare	-

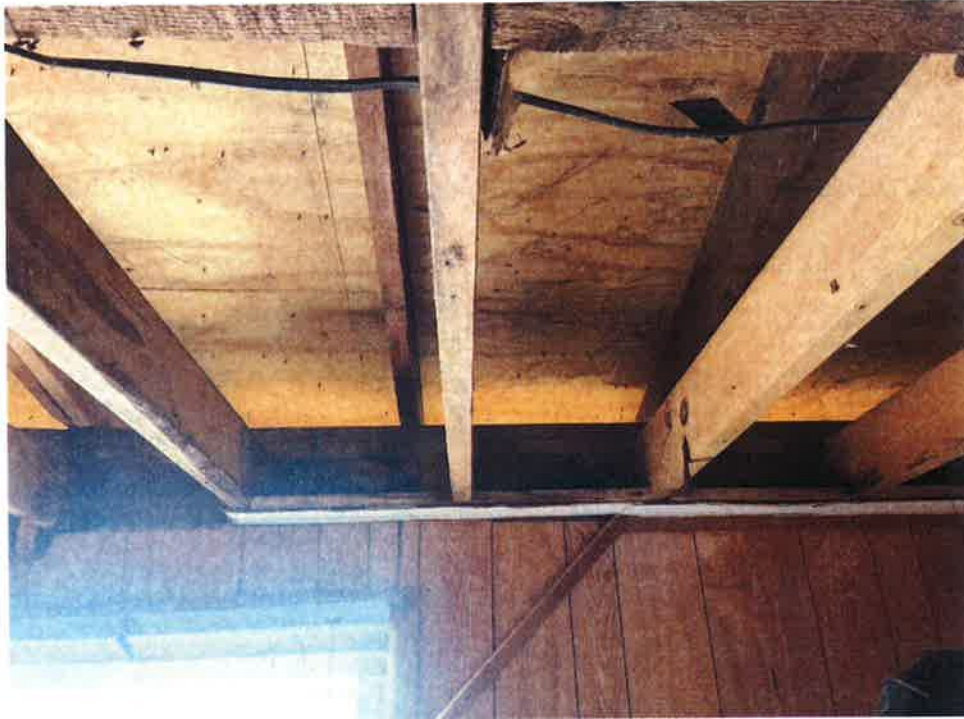
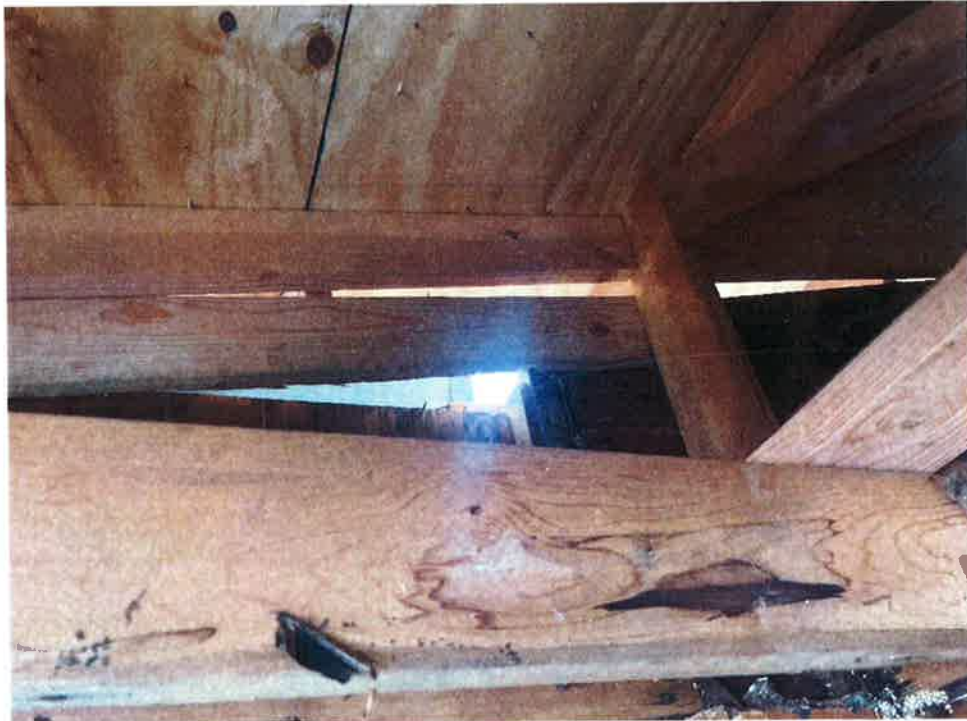
The Residential Building located at 121 Providence Street in Waverly, NY is a two-story wood framed structure constructed on a partial basement. According to Visual Observations, the source of the water infiltration was a hole in the rear roof which allowed water to infiltrate the building for an unknown period of time.

The roof was recently completely replaced and the water infiltration as ceased. Now that the source of water infiltration has been corrected, the extent of subsequent water damage must be determined and corrected, as well as any potential mold growth.

1F Laundry Room @ Ceiling – New Roof Base installed – visible light indicating opening to outside

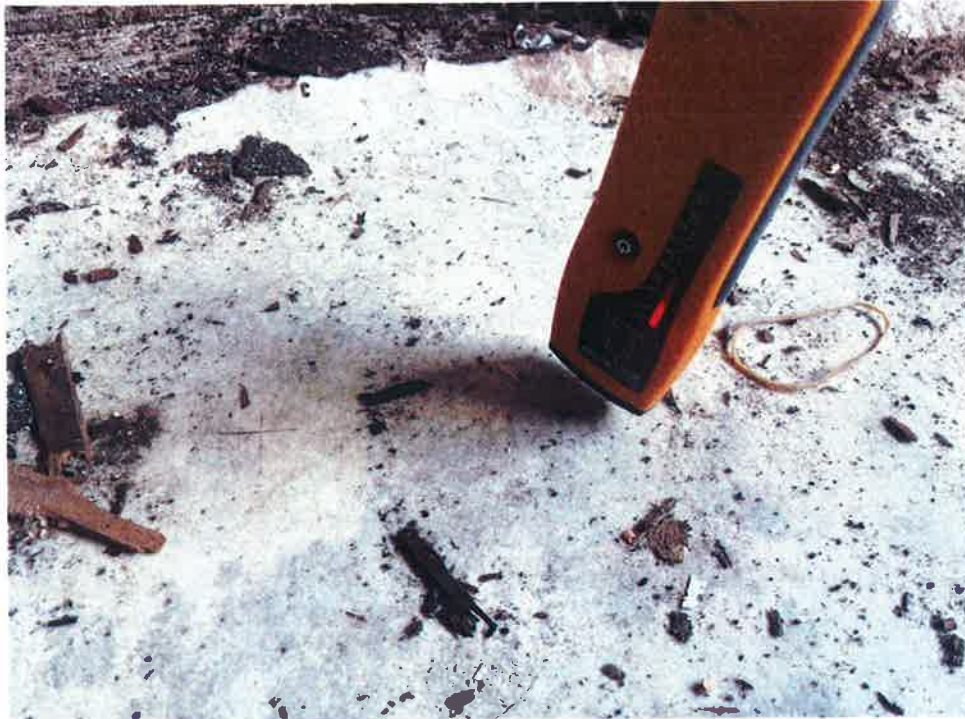
Various locations and surfaces were tested to determine the moisture content. The Assessor started at the source of the water infiltration in the 1F Laundry Room, and continued out from there. The moisture content of every surface in the Storage Room was pegged at >30% WME. Adjacent to that space, floors were around 20-25% WME, and walls were only above 15% at the lower foot. Once out of the adjacent rooms, moisture content of was around 5-10% for remaining ceilings, walls and floors.

30% WME reading at Floor of 1F Laundry Room

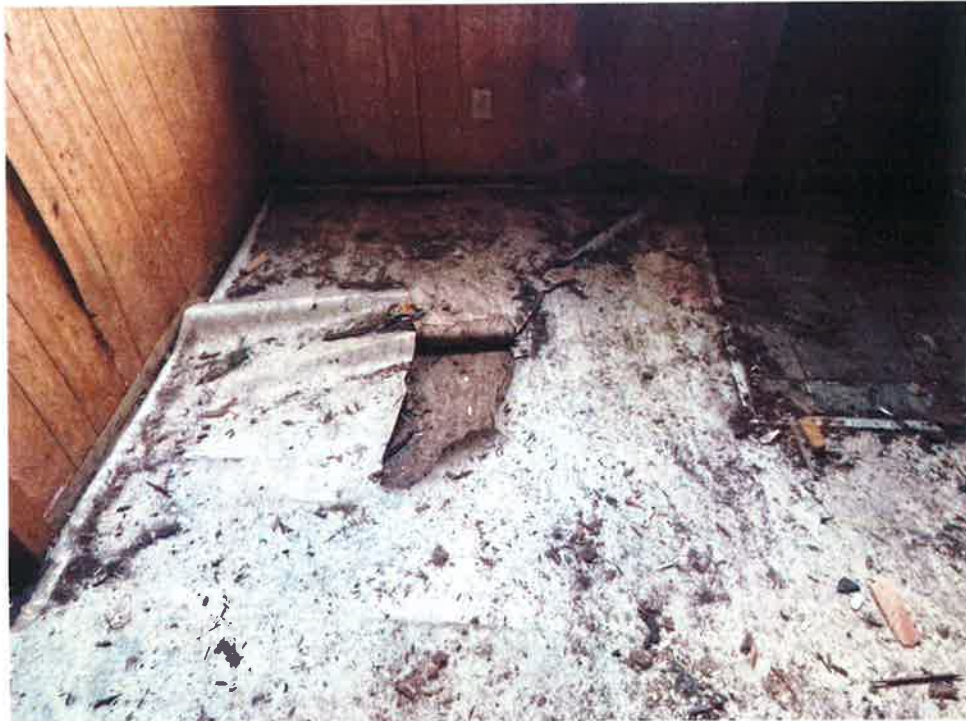
Delaminating Linoleum Floor in 1F Laundry Room

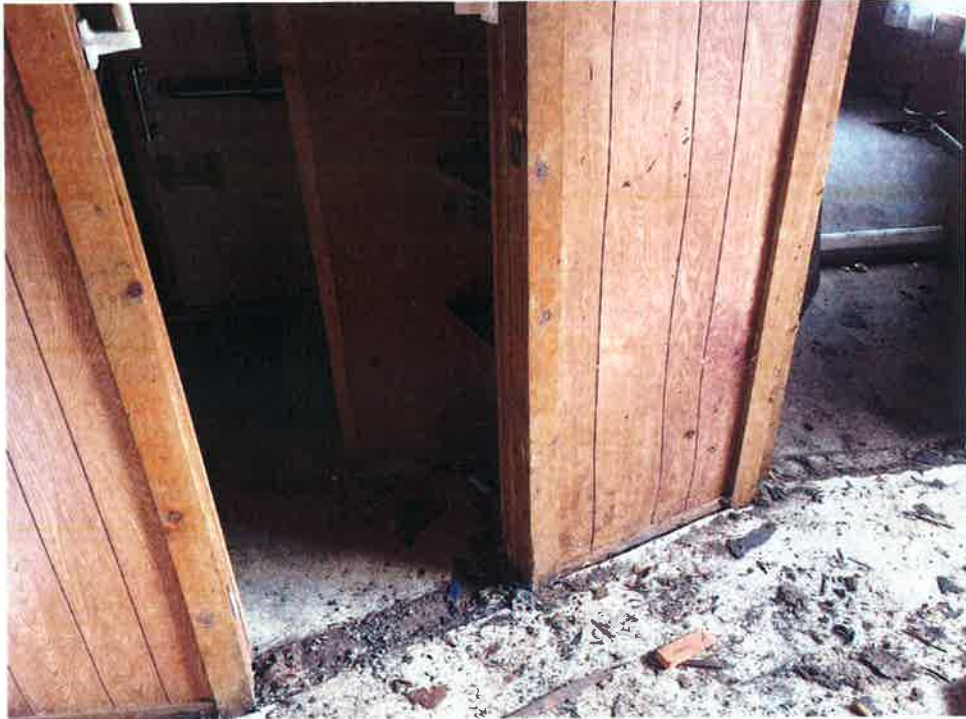
Water Damage debris on floor, and mold growth on wood paneling

- Removal/Decontamination of Water Damaged/Mold Contaminated:
 - Wood Trim
 - Ceiling Tiles
 - Drywall Ceilings
 - Plaster Ceilings
 - Wood Paneling
 - Drywall Walls
 - Plaster Walls
 - Carpeting/Flooring
- Any remaining insulation behind removed ceiling/wall board should also be removed. This includes the area above ceilings, and behind walls.
- Wood studs and sheathing where drywall and insulation has been removed, should be treated with a biocide/anti-microbial agent which will kill any active fungal spores.
- Wet Wipe and HEPA Vacuum all affected surfaces within the Residence, and allow building materials time to adequately dry.
- Clearance Air Sampling in the remediation area (and exterior control sample for comparison) to verify the remediation project was effective and the area is safe for re-occupancy.

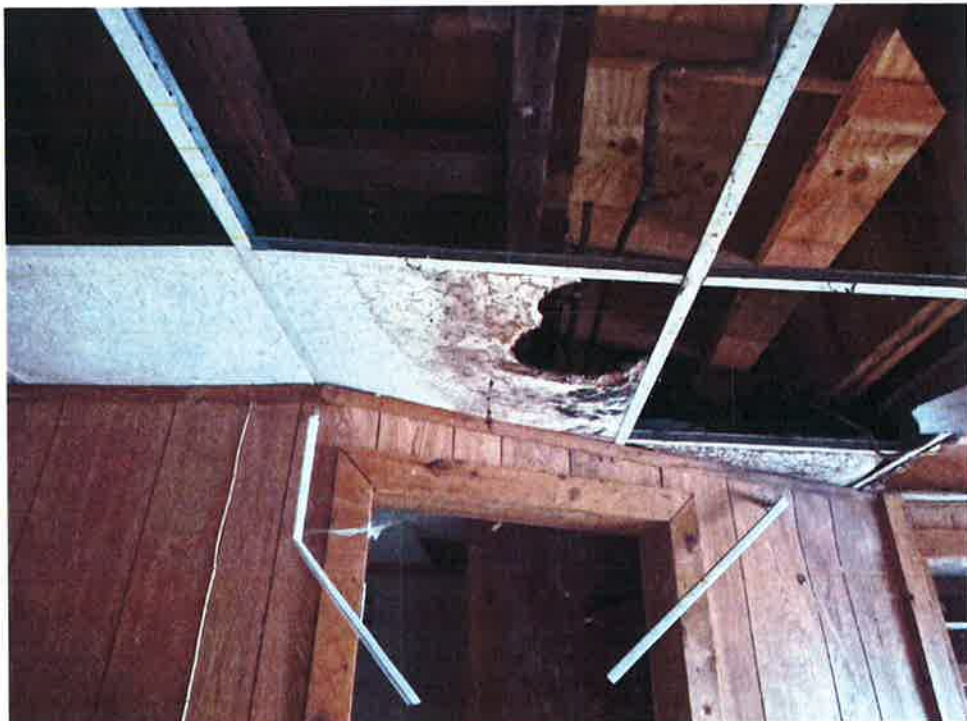
Missing/damaged Suspended Ceiling system. Mold growth visible as well.

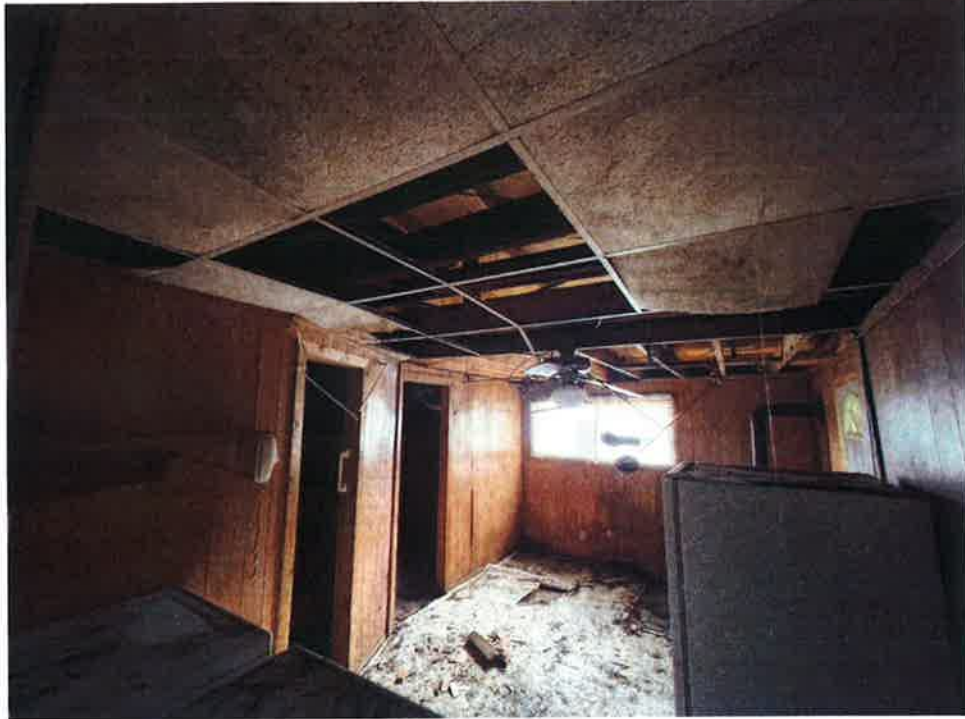
Wide view of 1F Laundry Room – missing SCT, debris on floor, delaminated flooring

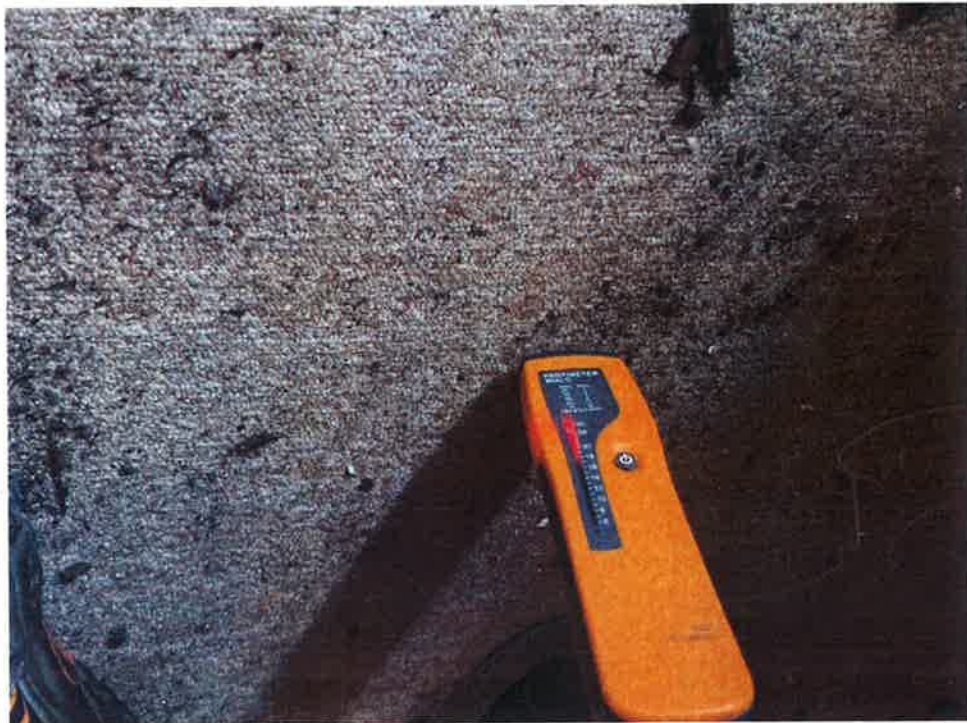
30% WME at Carpet Flooring in 1F Bedroom Closet (adjacent to 1F Laundry Room)

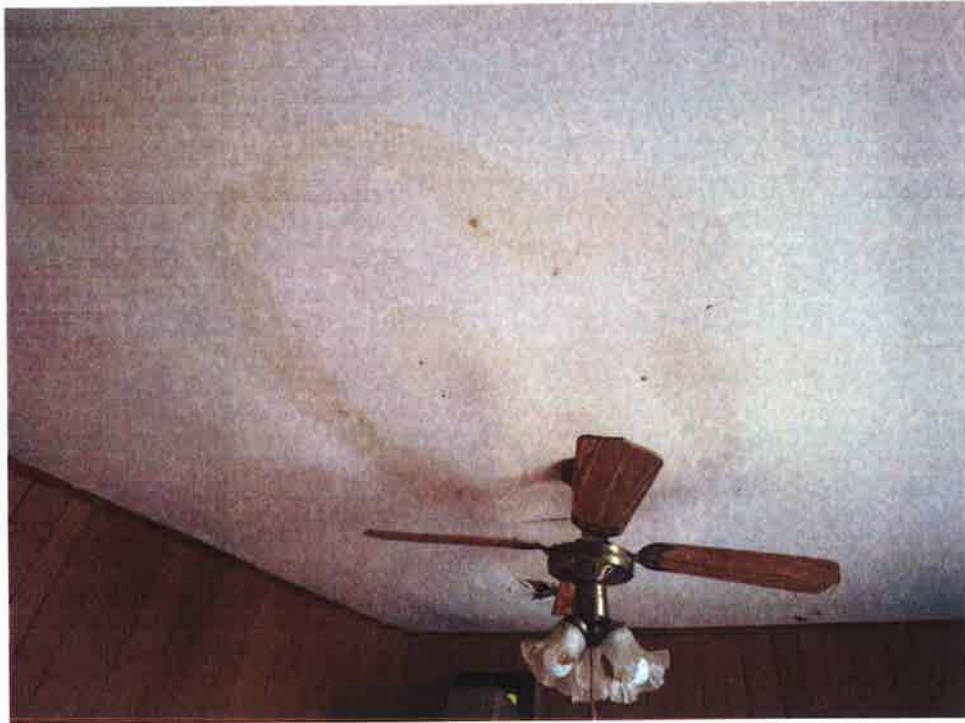
Water staining at ceiling in 1F Bedroom

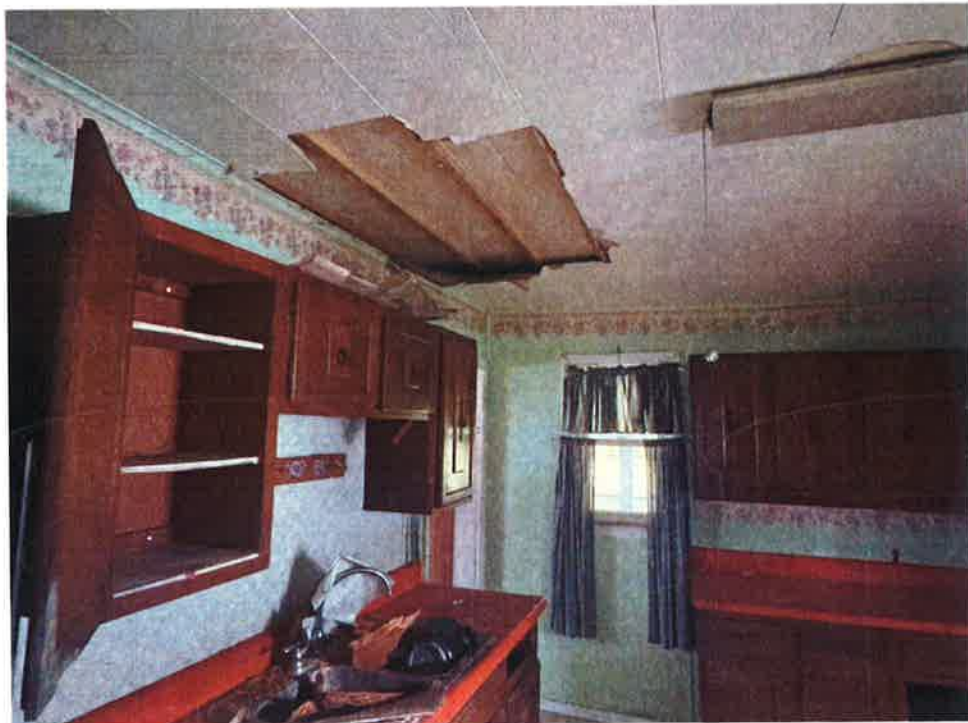
1F Kitchen Ceiling – missing damaged ceiling tiles

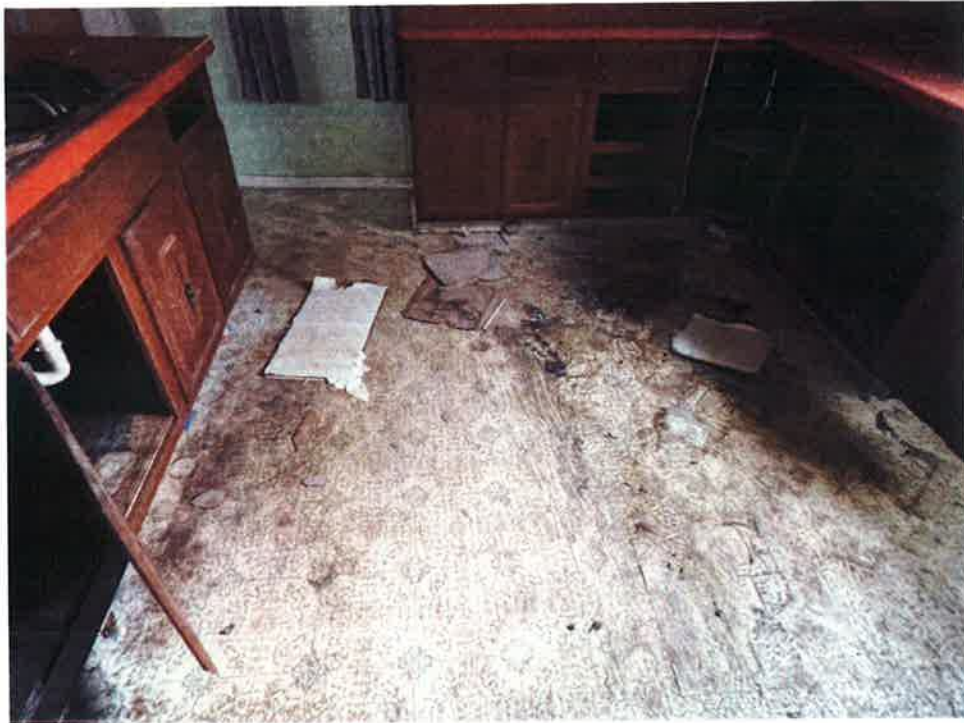
1F Kitchen – soiled linoleum flooring and fallen ceiling tiles

Room/Location	Impacted Material	Directions	Quantity
1F Kitchen	Adhered Ceiling Tiles, Wood Joists, Wood Paneling, Plaster Wall (?), Blown-In Insulation (?), Wood Supports, Linoleum Flooring, Wood Subfloor	Remove and Dispose Water Damaged Adhered Ceiling System, Wood Paneling @ Wall, Plaster @ Wall (if present), and any associated Insulations. Linoleum flooring should be removed in its entirety down to wood subfloor. Remaining wood to be clean, treated & dried.	Ceiling ~167 ft ² Walls ~339 ft ² Floor ~167 ft ²
1F Bedroom	Drywall Ceiling (Asbestos), Wood Wall Paneling, Plaster Wall, Blown-In Insulation, Wood Supports, Carpet Flooring, Hardwood Floor	Remove and Dispose Drywall Ceiling (Asbestos), Wood Paneling @ Wall, Plaster @ Wall (if present), and any associated Insulations. Carpet flooring should be removed in its entirety down to wood subfloor. Remaining wood to be clean, treated & dried.	Ceiling ~130 ft ² Walls ~275 ft ² Floor ~130 ft ²

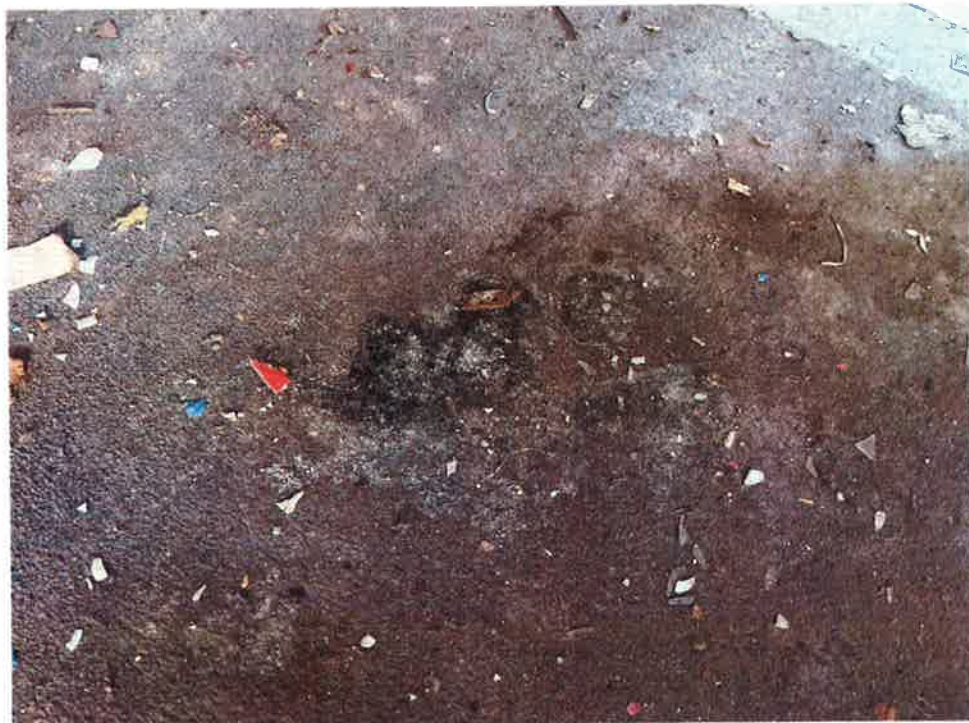
1F Living Room – Nasty spot at carpet flooring – verified to be a plethora of mold

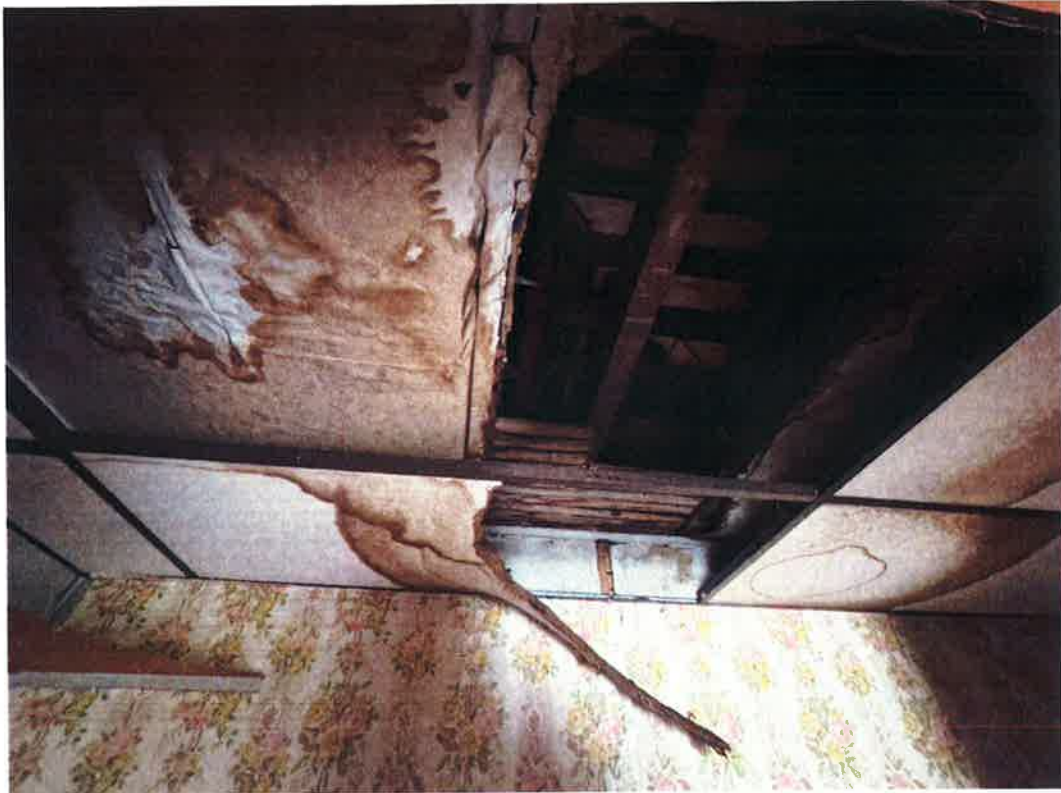
2F Front Bedroom East Closet – water staining with damage on old plaster & suspended ceiling
