**Request for Proposals for  
Partial Demolition of  
247 Main Street  
Owego, NY 13827  
Tax Map No. 128.08-4-41**

# 1 Basement Demolition Plan

**RESIDENTIAL STRUCTURE  
247 MAIN STREET  
OWEGO, NEW YORK 13827**

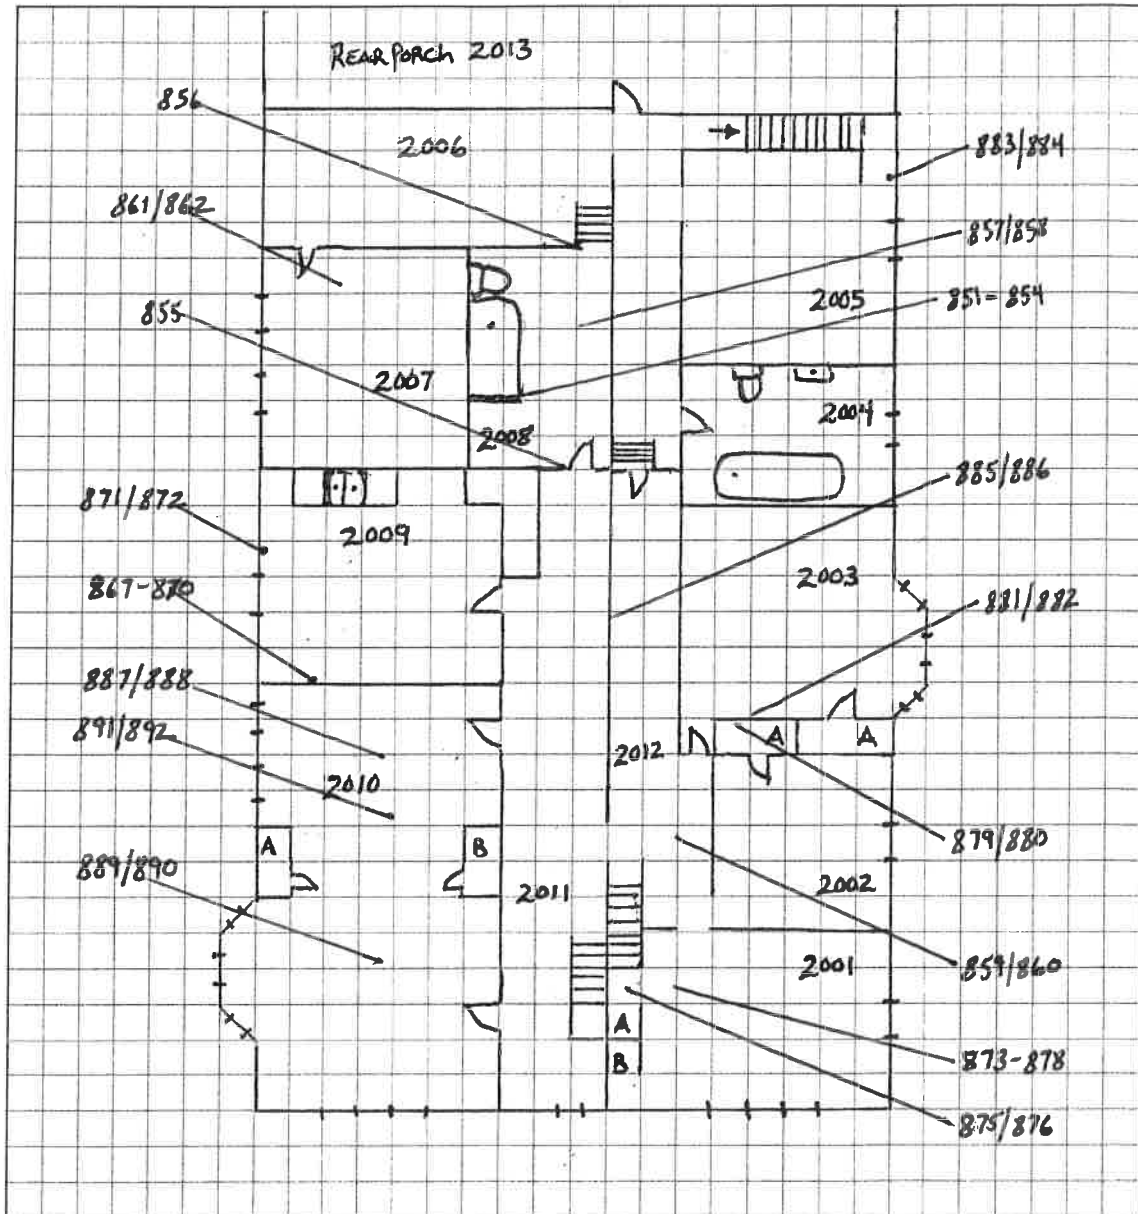
**ASBESTOS SAMPLE LOCATION DRAWING**

Location: SECOND FLOOR
